# HERMITAGE 85 IN NAQLUN: MATERIALS AND CONSTRUCTION

Szymon Maślak

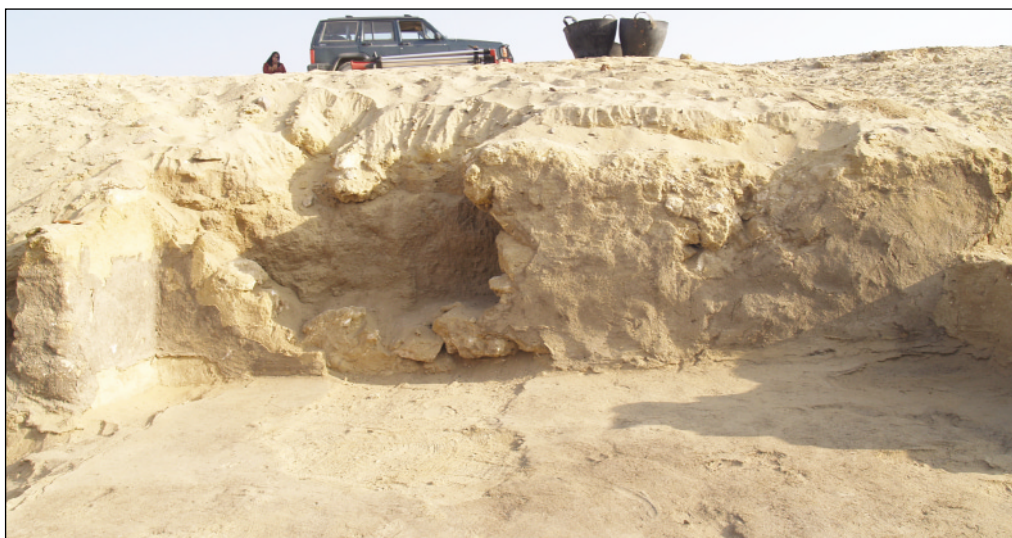
Fig. 2. Remains of a mud floor and mud plaster on the walls of Room 5, view looking n  
(Photo W. Godlewski)

In other units, more of a domestic or living character, the walls were plastered in a different way. Preserved fragments show that at least the lower parts were covered with a thin coating (2-6 mm) of dark gray mud plaster containing fine chaff, smoothly passing into a floor made of the same plaster. Plasters of this kind are laid usually on a relatively thick underground (up to 2 cm) of grayish or pale-gray-beige plaster, both produced from raw material of desert origin.
