## CONSERVATION WORK AT MAREA IN 2007

Barbara Wrońska-Kucy

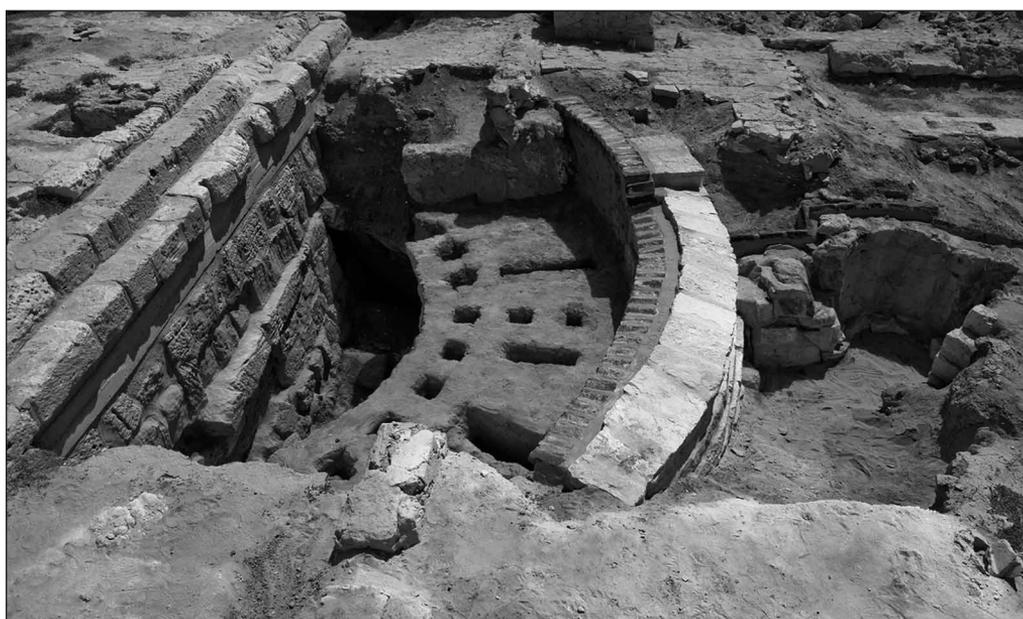
*Fig. 1. Basilica presbytery area, general view, condition after the season in 2007. Note pottery kiln wall and baptistery font (Photo J.M. Kucy)*

masonry structures located within the presbytery area of the basilica, namely, the baptismal font and the earlier structure of the pottery kiln [Fig. 1].

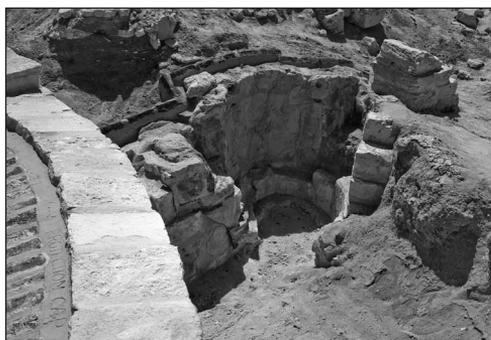
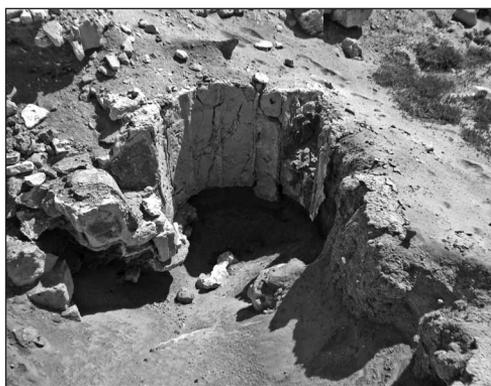
Less than half of the baptismal font has survived over the ages, including fragments of the steps and south half of the basin [Fig. 2, top] erected of limestone blocks and red baked brick. The undermined structure, missing floor and footing, was in danger of collapse. The east and west steps of the font were lined with waterproof plaster (*opus signinum*), and the basin was lined with a white limestone mortar bed featuring imprints of the finishing tiles (the latter not preserved). All the coatings were severely deteriorated, cracked and displaced and in

Fig. 2. *Baptismal font, condition before (top) and after stabilization and conservation (Photo Jack M. Kucy)*

danger of detachment. The entire assembly was in immediate need of structural stabilization and conservation of the finishes.

First of all, the steps and the basin of the font had to be supported [Fig. 2, bottom]. The new footing was constructed of limestone blocks set on a surface hardened with crushed brick, stone and light mortar soil, approximately 30 cm below the floor of the font. A small fragment of the basin, adjacent to the east steps, was supported and protected with a low retaining wall constructed of the limestone blocks set in lime mortar. All major voids between new support stones and the font were filled in with limestone mortar. The old structure was consistently separated from the new work with strips of bituminous membrane. After stabilization of the structure, conservation work on the preserved surfaces of the font was executed and included cleaning of the surfaces and cavities with water, filling the cracks and voids beneath the plaster with grout (a, for specification of materials used, see below), re-adhering edges of the plaster (b), and filling in the plaster cracks with grout (a) and mortar (c). Finally, all surfaces were dusted, desalinated and impregnated (d). The basin was backfilled with loose soil to the top of the new footing. Drainage was ensured in the ground and low provisional curbs were built around the font to limit water accumulation in this area.

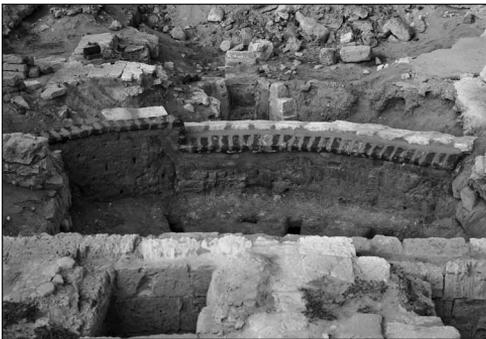
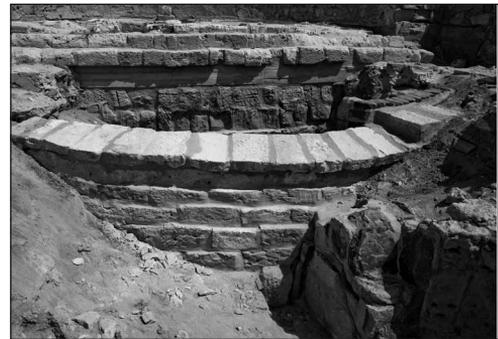
The outer wall of the pottery kiln, constructed of dried mud brick, was the object of conservation and protection during the previous season of 2006. Due to mechanical damage incurred over the past year to the temporary coping installed over the kiln's wall, and erosion of a soil infill found back of the wall, the method of protection needed to be revised. Provisional mud-brick copings installed during the last season and compatible with the original fabric, as well as a mud-mortar infill were noted to perform very well in protecting the original wall from mechanical damage. Mud mortar took impact well and had not been vandalized; the copings remained in excellent condition. All things considered,

Fig. 3. Outer wall of the kiln, inboard face (left) with new mud-brick infill and brick and stone coping, and outboard face (right) with new retaining wall and coping (Photo Jack M. Kucy)

The exterior face of the mud wall, now exposed, required a new backing at the very least. The new retaining wall [Fig. 3] was constructed of limestone blocks collected on site, set approx. 20 cm from the kiln's mud wall. The cavity was filled loosely with earth collected on the site. The mud-brick copings installed last season were reused to level the wall crown, set in a mud mortar [Fig. 3, right]. A new cantilevered limestone coping set on a new retaining wall, and a brick cap over the kiln wall (set on angle to discourage walking) were installed, separated from the original wall with bituminous membrane to prevent water penetration. As

a result, the original wall of the kiln is protected with a slightly higher outer stone wall and coping, capable to withstand accidental impact. The new wall has a distinctively different bond from any

original structures on site, but it blends in visually with the surroundings. If needed, it can be easily dismantled in the future, when conditions are created to protect this site permanently.
